MEMORANDUM

SUBJ: Extent of Contamination Study Conducted on 16 and 23-25 June and 7 July 1998
TDD.No. 98-06-0010-A, PCS No. 5303, DC No. R-1557

JARD COMPANY INC.
 BOWEN ROAD
 BENNINGTON, VERMONT

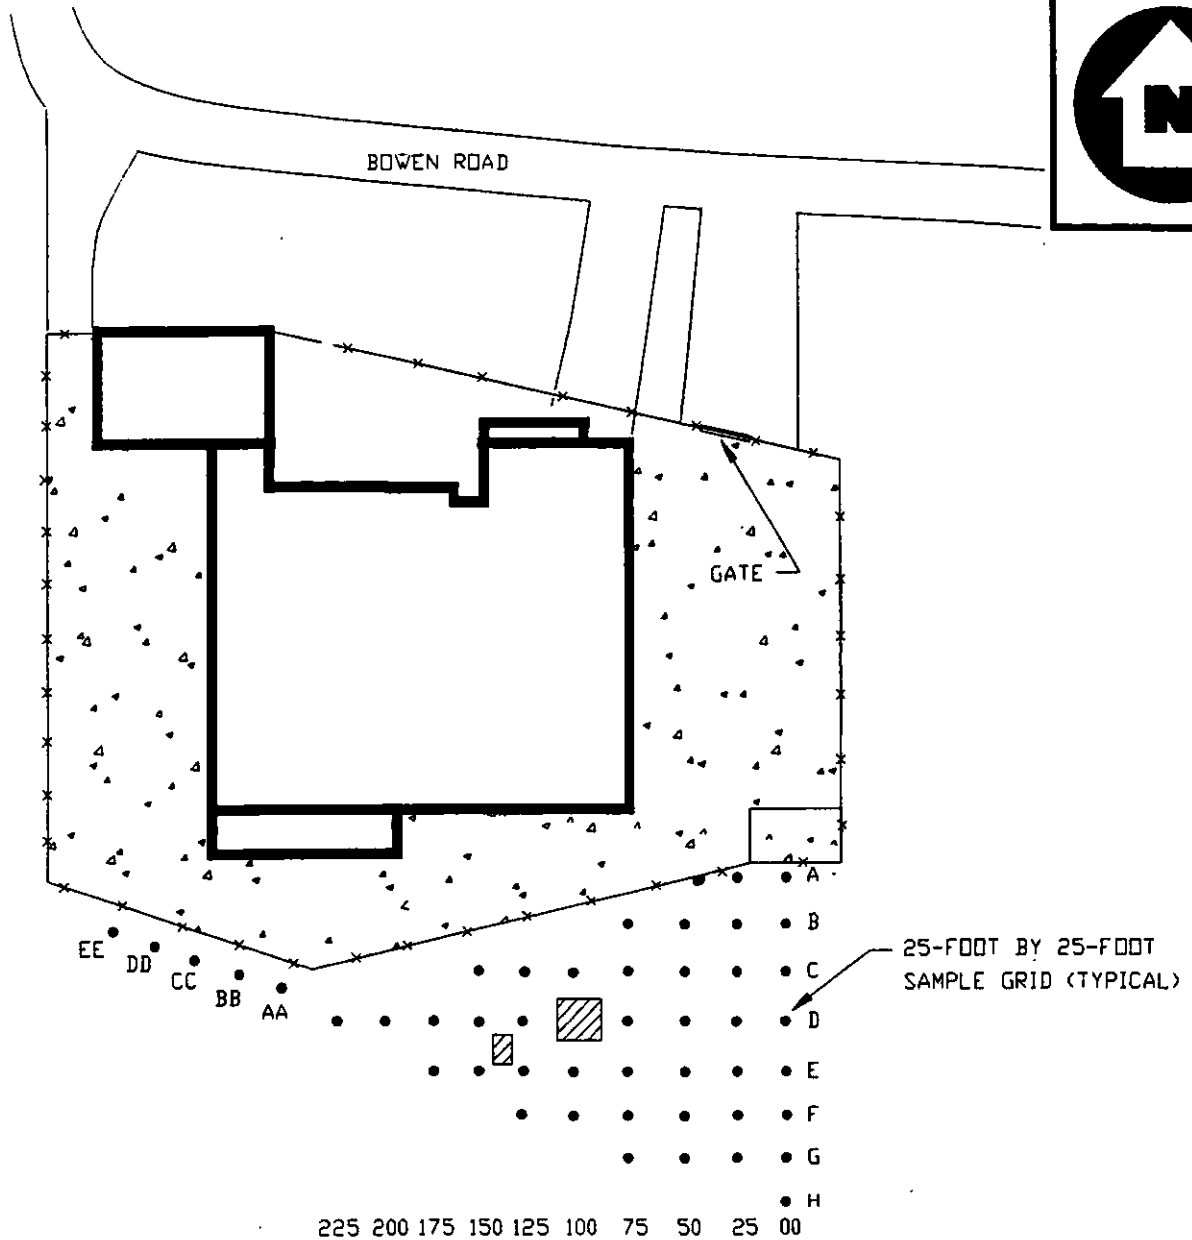
FIGURE 4

SAMPLE LOCATION DIAGRAM
JARD COMPANY, INC.
BENNINGTON, VERMONT

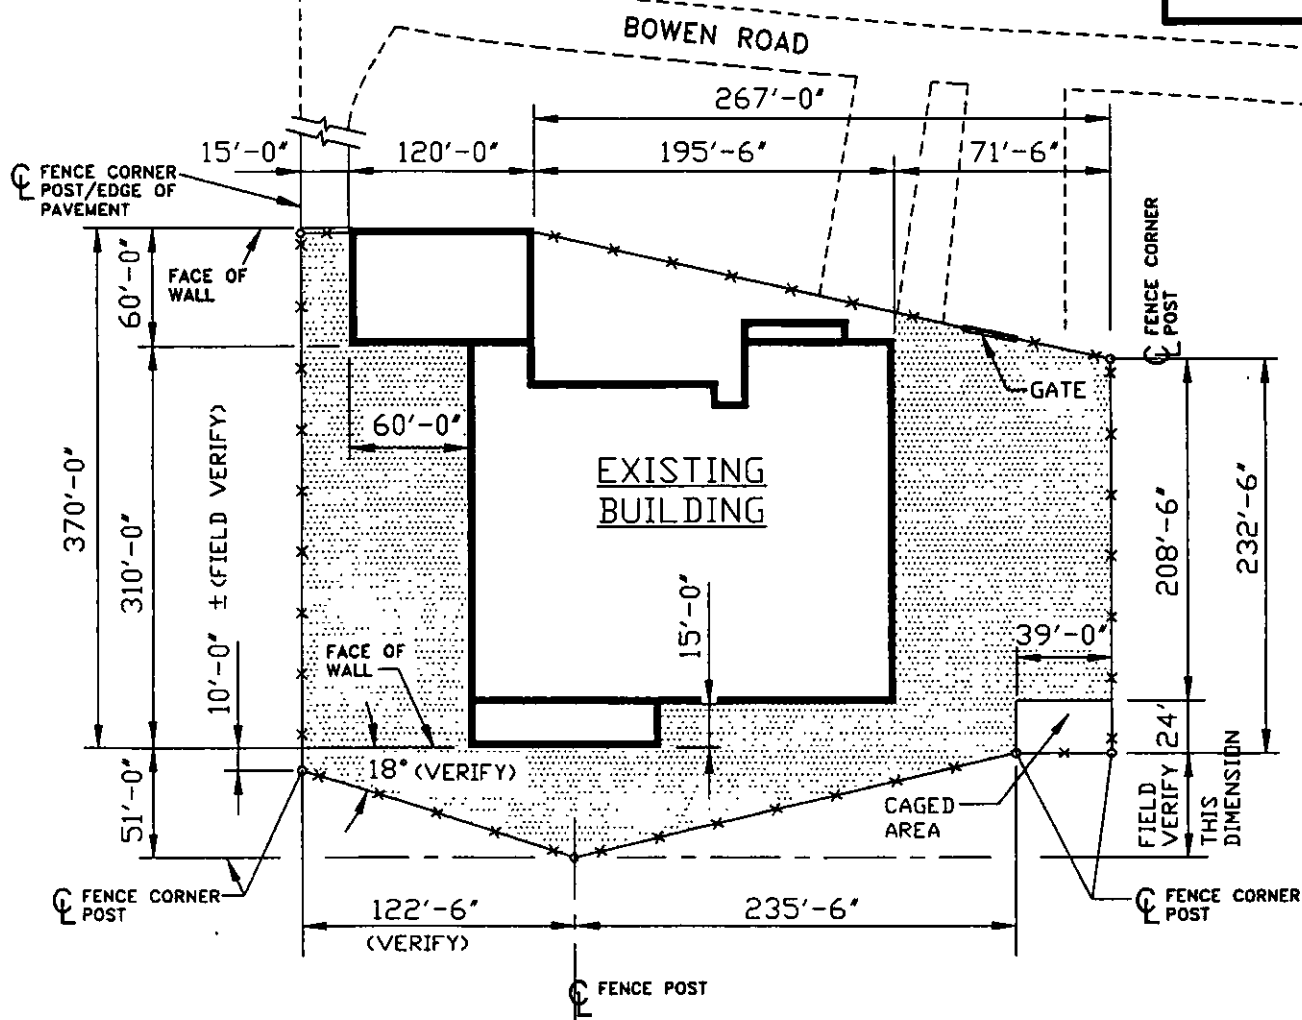
FIGURE 3

ALL DIMENSIONS TO BE FIELD VERIFIED PRIOR TO FABRICATION OF FENCE
APPROXIMATE LENGTH OF FENCELINE IS 1,200 FEET (±50 FEET)
APPROXIMATE AREA TO BE PAVED IS 56,000 SQUARE FEET (±1,000 SQUARE FEET)
APPROXIMATE AREA TO BE PAVED IS 56,000 SQUARE FEET (±1,000 SQUARE FEET)

SITE DIMENSION DIAGRAM
JARD COMPANY, INC.
BENNINGTON, VERMONT

On 16 June 1998, OSC Burke and START members Coppelino and Borci mobilized to the site to conduct a site inspection and to measure the length of the site fence, the area that was to be re-paved, and the area that was to be sampled by START (see Attachment III - Site Dimension Diagram).

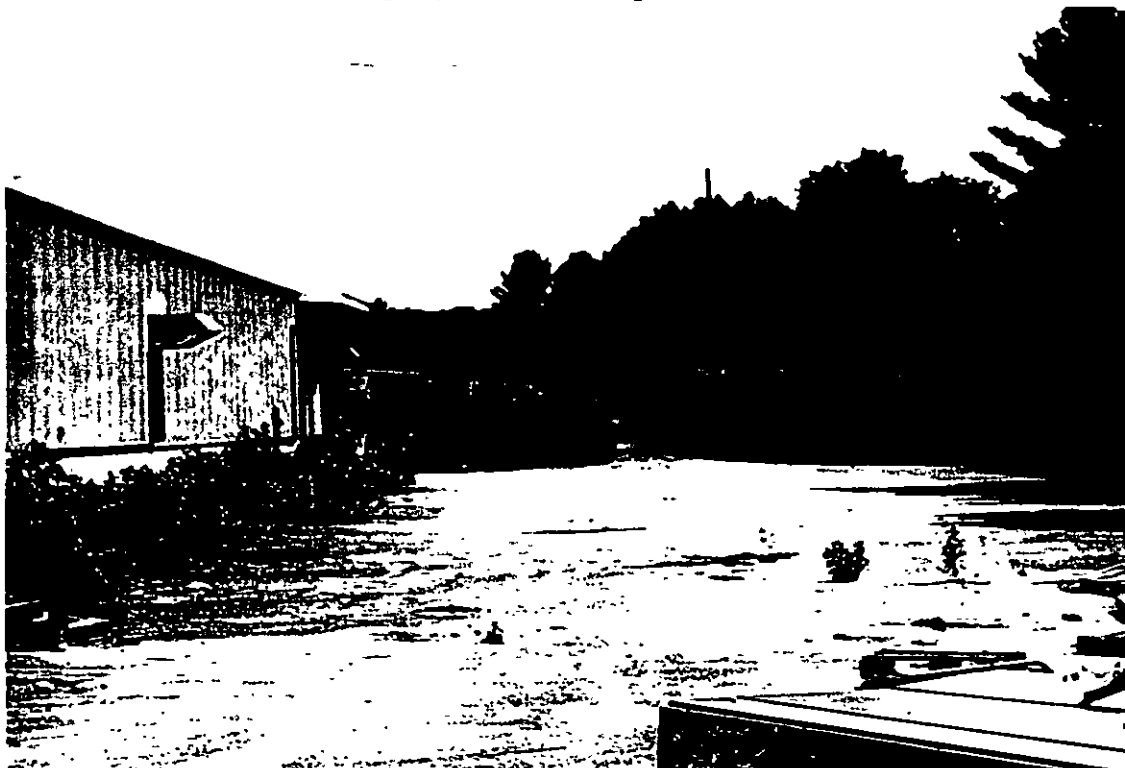
SCENE: View of back parking lot (facing north) note that the fence gate is open.
FRAME NUMBER: 01 **DATE:** 24 June 1998 **TIME:** 1100 **SKY CONDITION:** Cloudy
PHOTOGRAPH BY: Patricia Coppolino **WITNESS(ES):** Mandy Butterworth
CAMERA: Olympus **SETTING:** Automatic **FILM TYPE:** 35-mm **FILM ROLL:** 07766

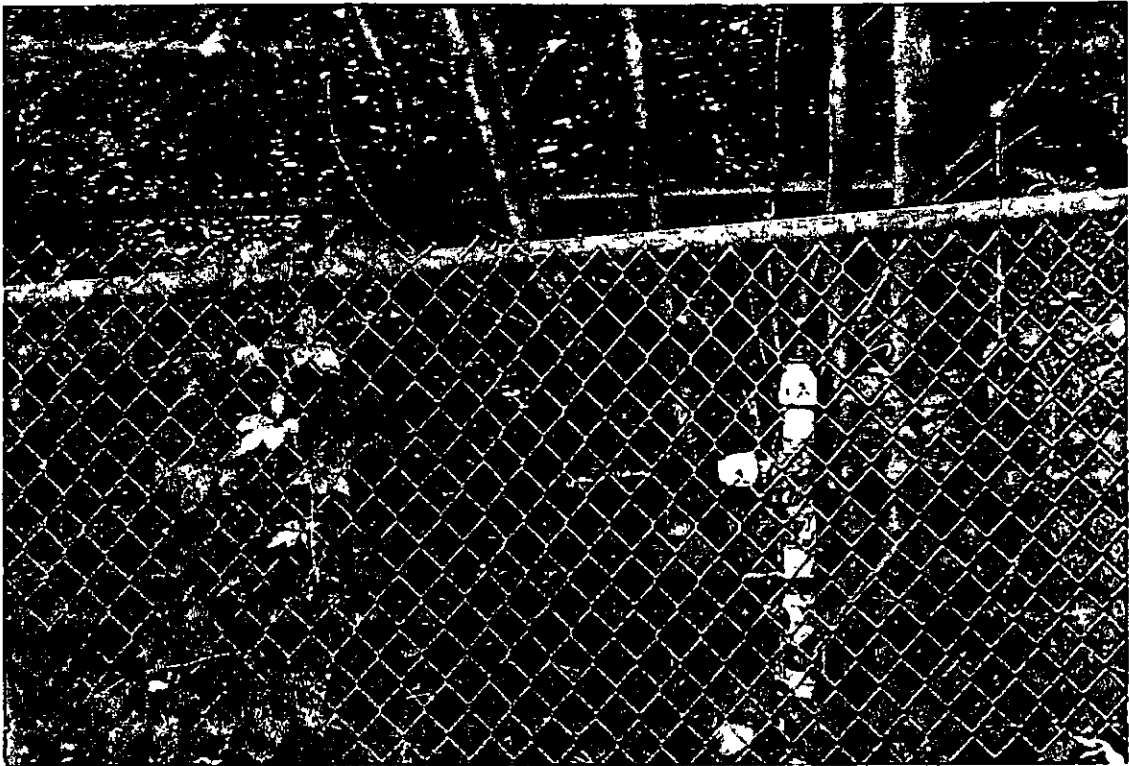
SCENE: View of a gas gage located within a fenced in area located between grid line D and E
FRAME NUMBER: 05 **DATE:** 24 June 1998 **TIME:** 1125 **SKY CONDITION:** Cloudy
PHOTOGRAPH BY: Patricia Coppolino **WITNESS(ES):** Mandy Butterworth
CAMERA: Olympus **SETTING:** Automatic **FILM TYPE:** 35-mm **FILM ROLL:** 07766

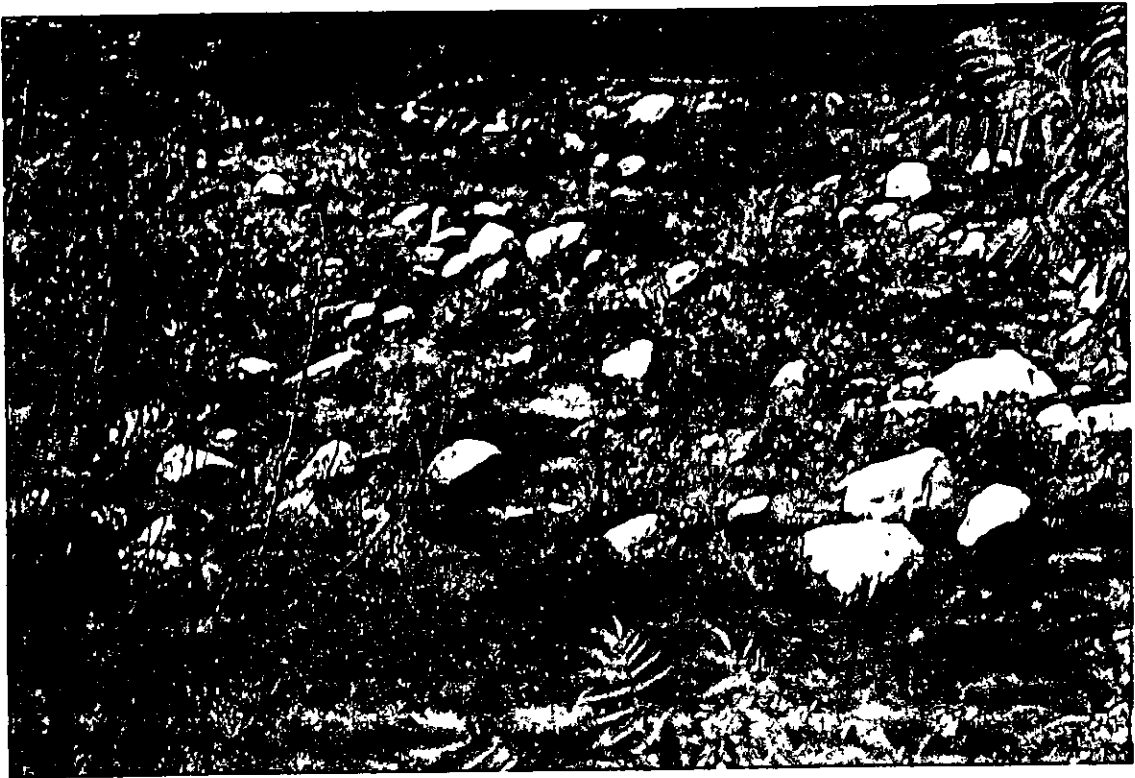
SCENE: View of roaring branch of the Walloomsac River (facing south), located 30 feet from H baseline.
FRAME NUMBER: 06 **DATE:** 24 June 1998 **TIME:** 1130 **SKY CONDITION:** Cloudy
PHOTOGRAPH BY: Patricia Coppolino **WITNESS(ES):** Mandy Butterworth
CAMERA: Olympus **SETTING:** Automatic **FILM TYPE:** 35-mm **FILM ROLL:** 07766
